## **A Novel Structural Health Monitoring Method for Reinforced Concrete Bridge Decks Using Ultrasonic Guided Waves**

# A Novel Structural Health Monitoring Method for Reinforced Concrete Bridge Decks Using Ultrasonic Guided Waves

**Abstract:** This article presents the latest improvements in a recently developed nondestructive testing (NDT) approach for early detection of various flaws (corrosion, delamination, and concrete cracking) in reinforced concrete (RC) bridge decks. The proposed method involves the use of internal steel reinforcement as a wave guide for transmitting ultrasonic waves through the system and the measurement of leaked energy from the surface of the concrete. This paper builds upon the progress made in the previously published phases of the project and aims to further explore the capabilities and practicality of the proposed NDT method. Specifically, the limits of propagation distance, effect of bidirectional reinforcement, methods of attachment and coupling of the sensors to the reinforcement and concrete, and suggestions for optimal sensor arrays are discussed in this paper based on the findings from the most recent laboratory tests and pilot field tests.

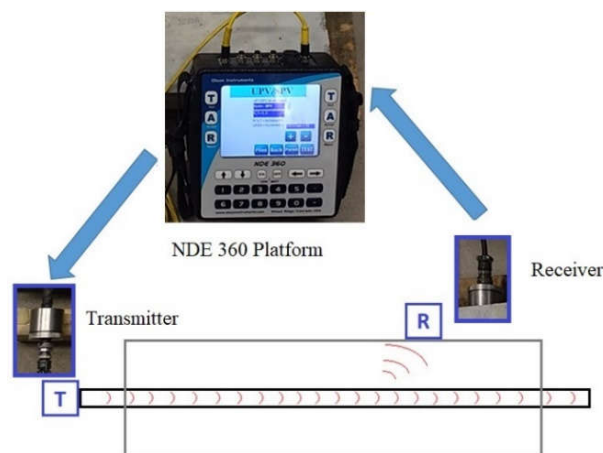
**Figure 1.** Ultrasonic experimental setup.

There are two unique aspects of the proposed methodology when compared to traditional ultrasonic testing. First is the utilization of the leaked energy from the ultrasonic guided waves into the surrounding concrete by coupling the transmitter to the steel rebar and receivers to the concrete surface (Figure 1). The hypothesis behind this approach is that, with a theoretical understanding of the wave propagation in steel and the leaked-wave propagation in concrete, the types and locations of different flaws (chemical corrosion, delamination, and independent cracks in concrete) can be identified.

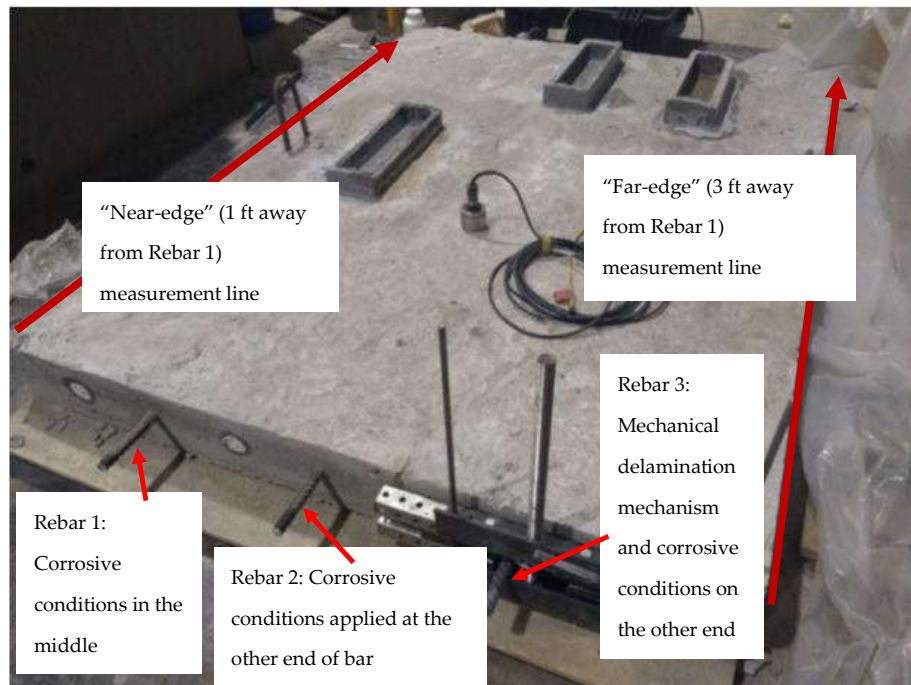
To achieve these goals, certain regions of the slab were cast using 5 percent NaCl solution (i.e., salt water) to localize the corrosive environment. Further, to accelerate the corrosion in these regions, concrete basins of 30.5 × 7.62 × 5.08 cm (12 in. × 3 in. × 2 in.) were cast in those regions above the reinforcing bars (Figure 2). These were filled with 5% NaCl solution to maintain a high chloride content in these regions and accelerate the corrosion process. Because the solution inevitably gets absorbed by the concrete and/or evaporates, the basins were refilled with saltwater solution every six days. The third steel reinforcing bar (the right-most bar in Figure 2) in this specimen was used to monitor the simultaneous development of corrosion and delamination. One end of the rebar was exposed to corrosive conditions for 24 days, while the rebar was simultaneously delaminated slowly at the other end over the same time period using the mechanical device shown in Figure 2.

**Figure 2.** Specimen Set 1—the applied corrosion and delamination conditions.

Two steel bars were monitored for the onset of corrosion: Rebar 1, where the corrosive condition is in the middle of the bar, and Rebar 2, where the corrosive condition is at the end (Figure 2).

Then the transmitter was placed on Rebar 2, which has a corrosion region at the start, roughly between 5 and 35.5 cm (2–14 in) from the transmitter end (Figure 2). Considering a leakage angle of 24 degrees, this corresponds to a corrosive region detection range as far as 63 cm (24.7 in.). As can be seen in Figure 11, the leaked wave amplitudes are considerably higher for the first four measurement points (until 61 cm from the end) for 24th day measurements compared to previous (0-day) readings, and they show a decrease from 76 cm onwards. The increase in amplitudes in the corrosion region is attributed to the improved bond between concrete and steel. It should also be noted that the velocity of ultrasonic waves through saturated concrete is greater than their velocity through dry concrete. Consequently, the attenuation can be less than the attenuation within dry concrete, keeping the readings from the concrete surface high. This can explain the fluctuations in the 0-day data in Figure 11. The decrease in amplitude of the guided wave after the corrosive region is also expected, as a significant portion of the guided wave already refracted into the surrounding concrete through the corrosion region.

The specimen shown in Figure 2 was also used to monitor the progression of corrosion and delamination simultaneously. Rebar 3 was exposed to corrosive conditions at one end while simultaneously being slowly delaminated on the other end of the rebar, over the same time period of 24 days. The guided waves were generated along the rebar from both ends. Figures 12 and 13 show the amplitudes of the array of sensors that was located 30.5 cm (1 ft.) away from the embedded reinforcing bar, with the guided waves transmitted along the rebar from the end with corrosive condition and from the end with applied delamination, respectively.

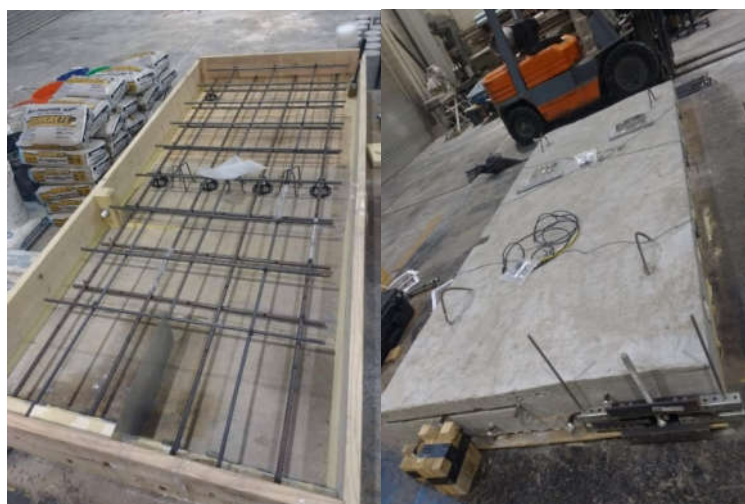
**Figure 3.** Specimen Set 2 formwork and bars before casting (**left**) and the final specimen (**right**).

The primary purpose of this longer (3 m or 10 ft.) specimen was to test at increased distances between the transmitter and receivers (Figure 3). Previous work investigated the propagation of the guided waves and the measured data (the leaked energy) over a maximum distance of 1.5 m (5 ft.), and the length of this specimen doubles that distance. A secondary purpose of the specimen set was to examine the influence of multiple layers and direction of reinforcement on the UGWL method. Finally, the specimen was used to evaluate whether the proposed method can detect a variety of flaws (corrosion, delamination, and cracks) in the same specimen.

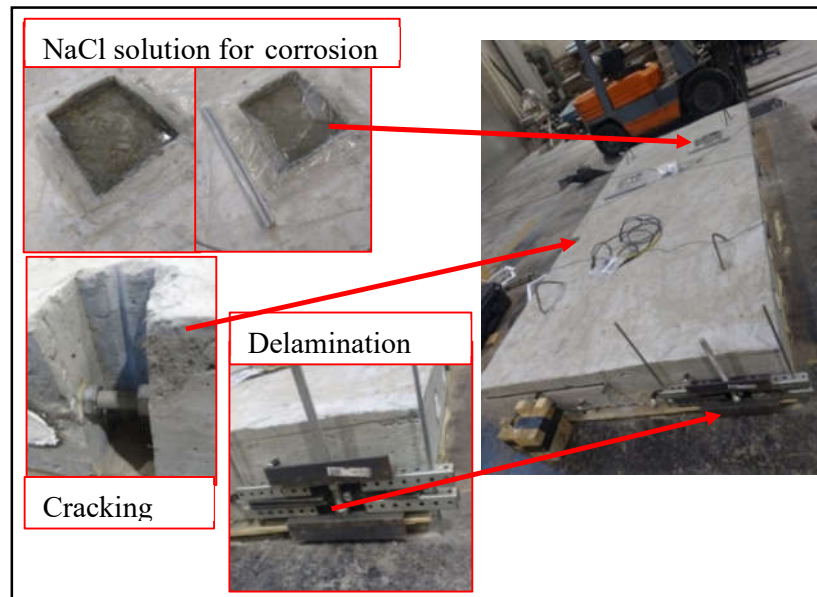
**Figure 4.** Specimen Set 2 and various areas of artificially introduced flaws.

Illustrations of Specimen 2 (photos in Figure 3 through Figure 5) are shown on the left side of Figures 14 and 15. In these drawings, the dark grey represents delamination and the yellow represents corroded areas. The reinforcing bar colored red in each figure indicates the reinforcing bar

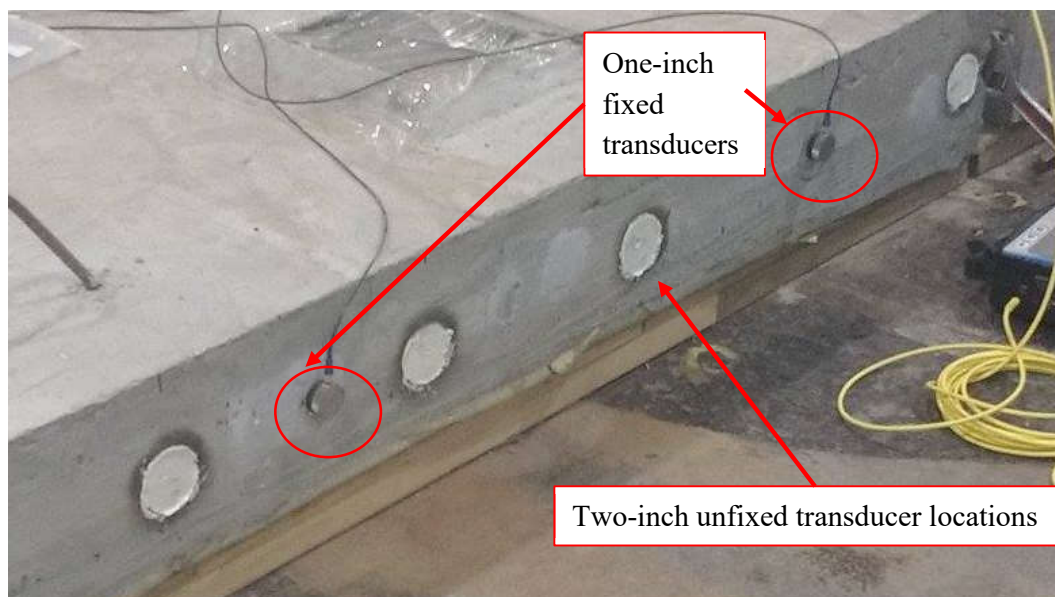
Specimen Set 2 was a larger reinforced concrete slab measuring 305 cm × 122 cm × 20.3 cm (10 ft × 4 ft × 8 in). This specimen was cast (1) to examine the influence of multiple layers and directions of reinforcement on the proposed UGWL method, (2) to test greater distances between the transmitter and receivers than those tested by previous experiments, and (3) to evaluate whether the proposed method can detect a variety of flaws (corrosion, delamination, and cracks) in the same specimen (Figure 3). Each layer of reinforcement had a cover of 6.35 cm (2.5 in.) from the outer surfaces and 7.62 cm (3 in.) of vertical distance between them. The specimen contained known areas with delamination and corrosion and a mechanism to create artificial cracks, as shown in Figure 4. Artificial cracking was intended to simulate cracks perpendicular to the surface that can be caused by a variety of reasons in the field and not as a separation between the rebar and the concrete. An array of sensor locations was marked on the side of the slab as shown in Figure 5.

**Figure 5.** Specimen Set 2 sensor locations.

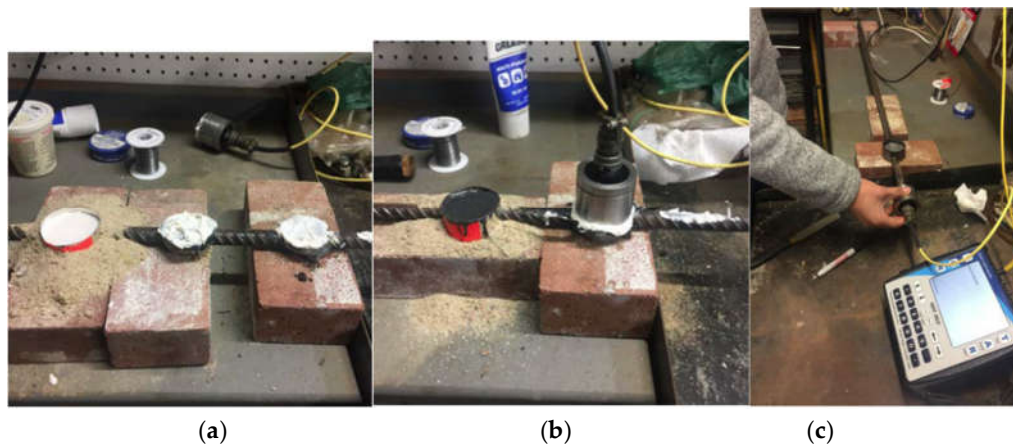
1. The transmitter was coupled directly to the end of the rebar;
2. A 5.1 cm (2 in.) section of the rebar was ground flat, and the sensor was attached onto the rebar using a typical grease couplant;
3. A lead solder pad was created, where a sheet metal form was placed over the bar; sand was placed around the form as a seal to prevent solder leakage, and lead solder was melted onto the pad with a torch. The pad was filed flat after cooling;
4. A seat for the transmitter was created using steel-filled JB Weld epoxy, poured into a form around the bar; and
5. A seat for the transmitter was created using Hydrocal gypsum cement, poured into a form around the bar.

**Figure 6.** Attachment options: (a) Right to left: coupling via a solder pad, coupling via an epoxy pad curing in sheet metal form, and gypsum cement poured into sheet metal form; (b) Right to left: ground rebar and coupling with white grease, solder and epoxy pads fully cured; (c) Transmitter at the end of the rebar.

Specimen Set 3a comprised a single bar used to test various ideas for the attachment of the transmitter to the rebar in field conditions, as explained in Section 2.1.3 and shown in Figure 6. According to the experimental results (Table 2), the maximum energy transfer was achieved when the transmitter was coupled directly to the end of the rebar, which represents the original lab setup and aligns with the optimal wave propagation expected with wave guides. The second-greatest amplitude measurements were achieved using Hydrocal gypsum cement, despite perpendicular attachment to the rebar. This material also has a short curing time of approximately 20 min; therefore, it will not cause significant delays during field testing.

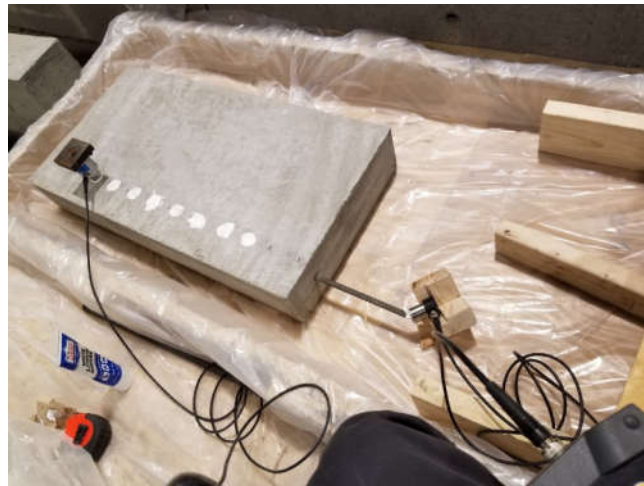
Specimen Set 3b comprised three reinforced concrete slabs that each measured 91.4 cm × 45.7 cm × 12.7 cm (36 × 18 × 5 in.) as shown in Figure 7. These slabs were cast with a 13 mm (No. 4) rebar embedded at the center slab cross section.

**Figure 7.** One of the Specimen Set 3 slabs, showing sensor locations.

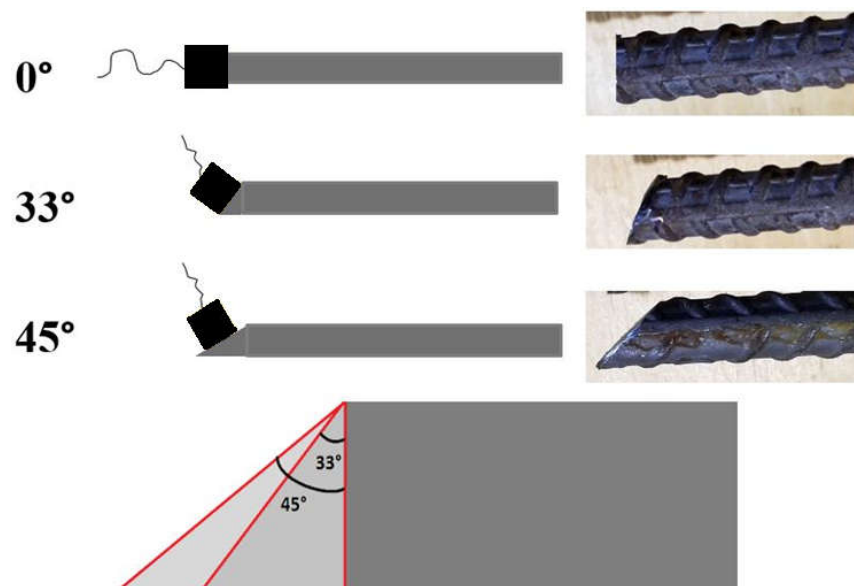
The purpose of this set of specimens was twofold: (1) to investigate via UGWL energy transmission with different bar end angles: 0 degrees, 33 degrees, and 45 degrees, cut with reference to the vertical axis, to simulate different transmitter-to-rebar attachment seat angles from the top of the bar (Figure 8); and (2) to compare two couplants to improve the coupling of the sensors to the test materials: Ultragel II from Magnaflux and White Lithium Grease from Lucas Oil Products.

**Figure 8.** Bar end angles.

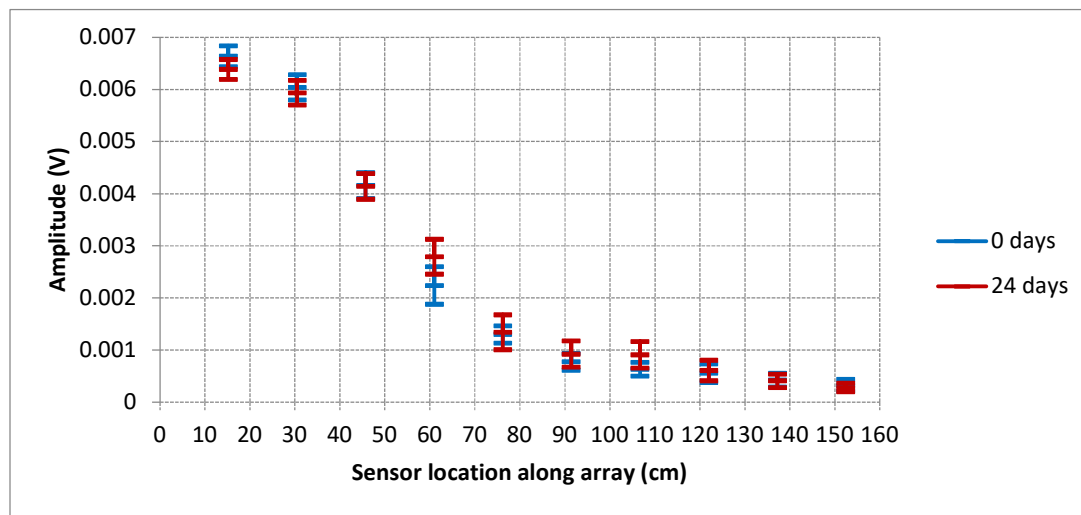
**Figure 9.** Amplitude of leaked waves versus sensor location plot for Specimen 1, with the transmitter on the corroded bar (Rebar 1: corrosion in the middle) and receivers 30.48 cm (1 foot) away from the bar.

The 24th day results (Figure 9) from the sensor array located at the near edge (30.48 cm or 1 ft away from Rebar 1) follow a typical attenuation of signals in an exponential curve, as expected, and show only a slight change in signal amplitudes at roughly the 60 cm (23.6 in) measurement point. The slightly increased amplitude correlates to the location of the start of the corrosion basin roughly at 46 cm (18 in). The actual location and the detected location are essentially the same when the leakage angles are considered, which are between 24 and 42 degrees. Figure 10 presents the results for the array of sensors placed at the far edge, and while the signals are, in general, only 28% of those obtained from the near end, a more obvious increase of amplitude at 107 cm (42 in) and 122 cm (48 in) along the array is observed. These locations also correspond to the corrosive region in the middle, considering the leakage angle, which is explained in the next section.

First, the ultrasonic waves were transmitted from the end of Rebar 1 and the leaked waves were detected from an array of sensors first on the near edge (1 ft away from Rebar 1 as shown in Figure 2) and then on the far edge (3 ft away from Rebar 1 as shown in Figure 2). The near-end and far-end results are presented in Figures 9 and 10, respectively, for zero corrosion (Day 0) and at Day 24.

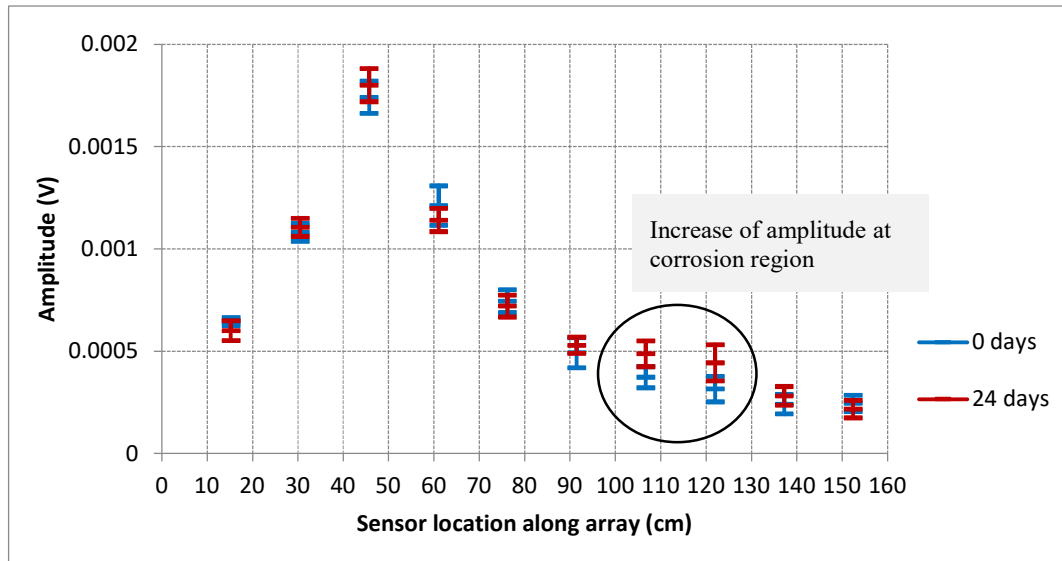
**Figure 10.** Amplitude of leaked waves versus sensor location plot for Specimen 1, with the transmitter on the corroded bar (Rebar 1) and receivers 91.44 cm (3 ft.) away from the bar (note that the vertical scale of this plot is 2/7 or 28% that of the plot in Figure 9).

Theoretically, the leaked bulk waves will propagate in two forms: longitudinal and shear waves. The leakage angle (or angle of refraction) may be theoretically calculated based on Snell's law which describes the relationship between angles of incidence and refraction when referring to waves passing through a boundary of two different media. The leakage angles for longitudinal and shear waves are calculated as 42 and 24 degrees, respectively [7]. This means that in Figure 10, for an array placed 91.44 cm (3 ft.) away from the bar used as the wave guide, there will be roughly a lag of 40 to 82 cm (16 to 32 inches) for signals associated with any localized flaws along the rebar. Given that the corrosive region is in the middle of the bar, roughly from 46 to 76 cm (18–30 in) of the 152 cm (60 in) long specimen, the expected locations of signal change for the leaked wave amplitudes range between 86 cm and 128 cm (34 to 50.4 in). The most clearly detected increase of signal is at 122 cm (48 in), which translates to a leakage angle of 26.6 degrees, well within the 24-to-42-degree range previously established. For Figure 9, where the signals are received at the near end of the concrete and the corrosive region starting around 46 cm (18 in) from the corrosive region, the detected increase at 60 cm (23.6 in) corresponds roughly to a leakage angle of 24 degrees.

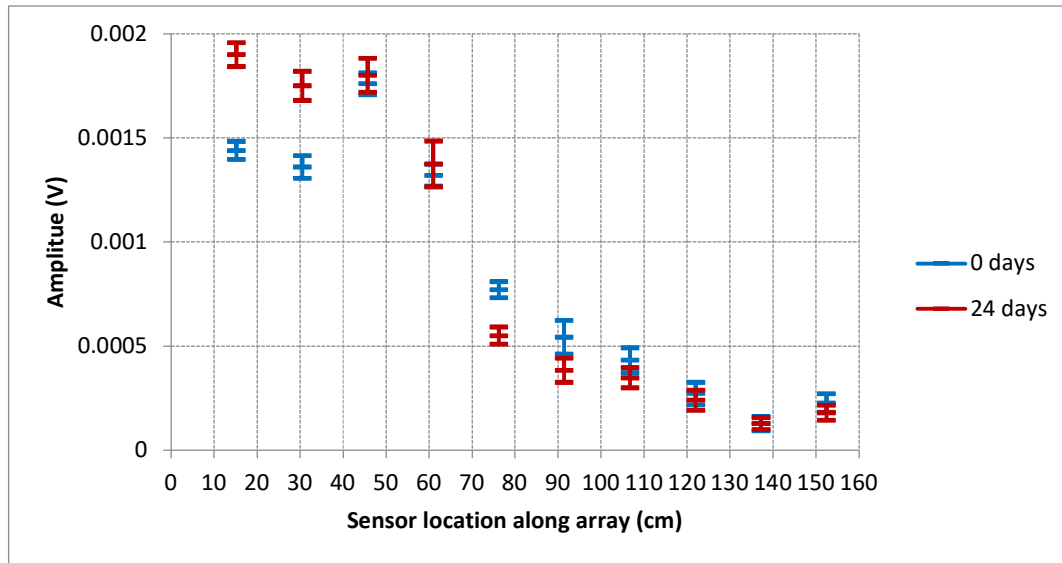
**Figure 11.** Results for corrosive conditions at the beginning of the rebar (Rebar 2) and the measurement array at the concrete edge, 61 cm (2 feet) away from the bar horizontally.

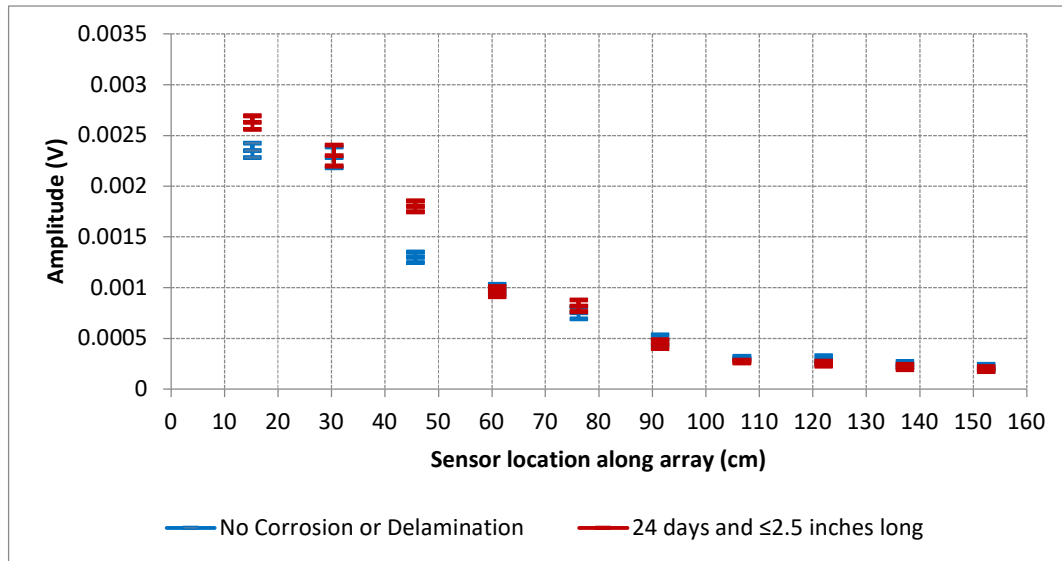
In Figure 12, an increase in the amplitudes can be observed through the corrosive region, and the amplitudes decrease beyond that. The delamination at the steel–concrete interface was 2.5 inches long at the 24-day measurements, and it can be seen in Figure 12 that it is difficult to discern the effect of the delamination *after* the corrosion-related decrease in amplitudes.

**Figure 12.** Corrosion and delamination test—Rebar 3: Transmitter located on the corrosion end and receiver array on the concrete edge 30.48 cm (1 ft) away from the wave guide.

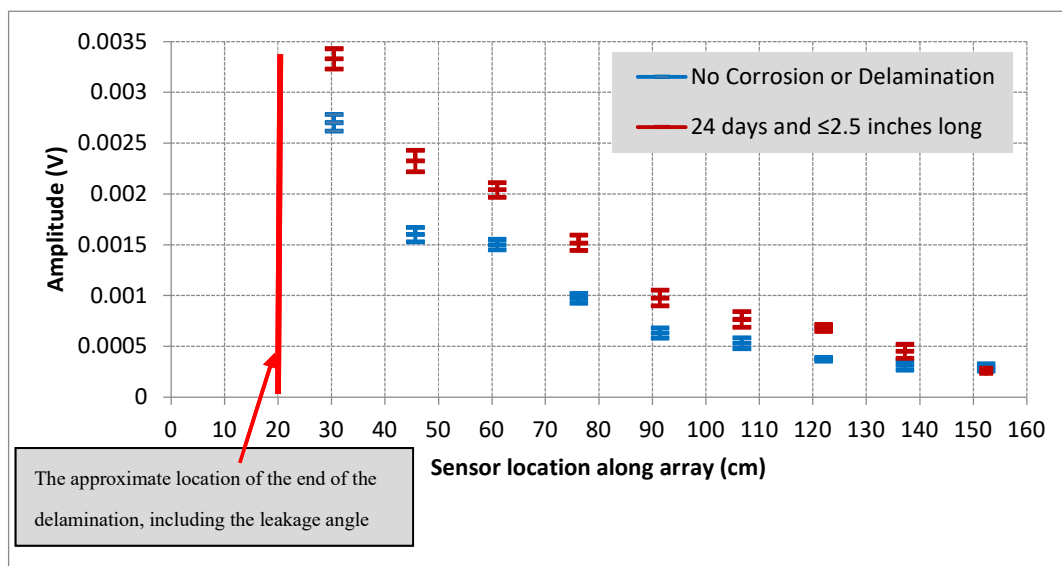
On the other hand, when the guided wave originated at the delamination end, the development of delamination caused significant increases in the leaked waves' amplitude monitored by any sensor located beyond the 6.35 cm (2.5 in) long delamination, which corresponds to 20–34 cm (7.8–13.3 in) considering the leakage angles of 24 to 42 degrees (Figure 13). This is because the energy stays in the wave guide when the connection with concrete is lost, producing no leakage. Once the location of the delamination is passed, there is more energy to leak into the surrounding concrete, increasing the amplitude of the readings. Also, the measurement points start at 30 cm from this end, due to the mechanism placed to create the delamination (Figure 2). Given that there were also corrosive conditions applied to the steel bar on the other end, the results shown in Figure 13 illustrate that at the start of the corrosive region, at 122 cm (48 inches) along the array, the amplitude appeared to increase more than at the other sensors. More notably, after the initial apparent increase, the amplitudes of the sensors beyond that saw decreases relative to the rest of the array, since the guided wave had already attenuated significantly by the time it reached the corrosive region. The variation in percent change in amplitude along the array is as follows: the percent increase in amplitude monitored by the sensor located at the start of the corrosive region spiked to 82%, while the rest of the sensors somewhat consistently increased around 40 to 60%.

**Figure 13.** Corrosion and delamination test—Rebar 3: Transmitter located on the delamination end and receivers on the concrete edge 30.48 cm (1 ft) away from the wave guide.

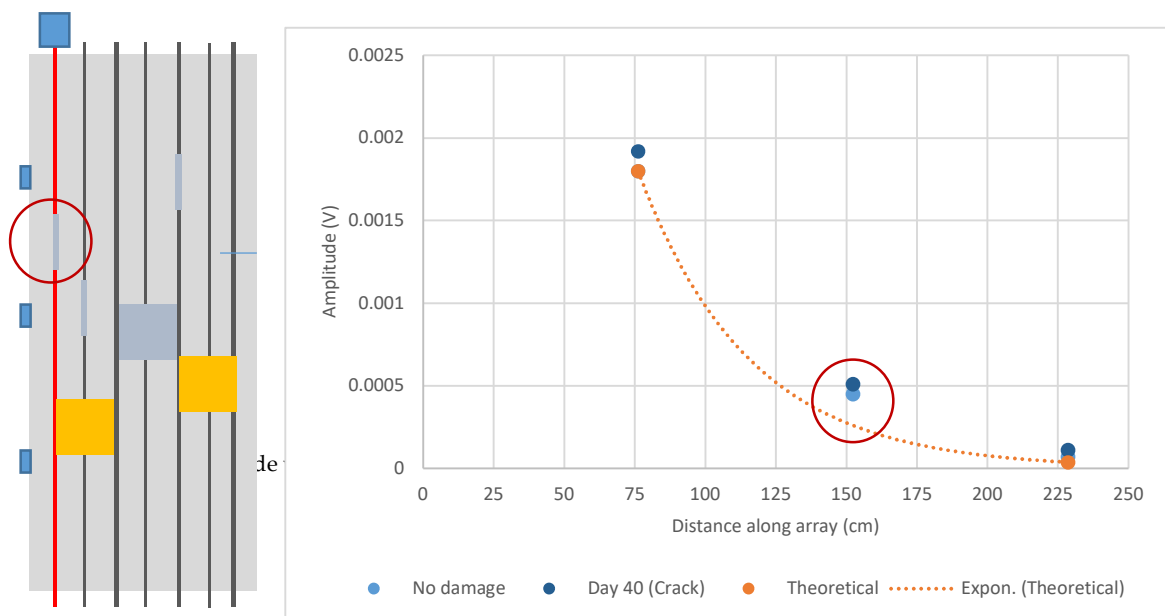
Figure 14 shows the results of the array of 1 inch transducers and displays the expected result of the increase in amplitude readings that occurs after (i.e., at the second sensor point) due to the artificially inserted delamination, in the form of a laminate wrapped around the rebar. As can be seen, given such a permanent interruption between the wave guide and the surrounding material, consistently higher amplitudes of leaked waves are detected in the sensor after the rebar. This is attributed to the fact that in the delamination region, more of the energy remains in the wave guide.

**Figure 14.** Amplitude versus distance plot for Specimen Set 2 using 1 inch transducers as sensors (an array of three sensors on the left side of slab) when the transmitter is placed on the far-left rebar.

In Figures 14 and 15, a theoretical curve is included. This curve was established using Equation (1). When guided wave attenuation is considered, the attenuation coefficient ( $\alpha$ ) describes the weakening of the signal due to scattering and absorption, and can also be considered as the decay of power or intensity of a sound wave [8]. This is defined by Equation (1):

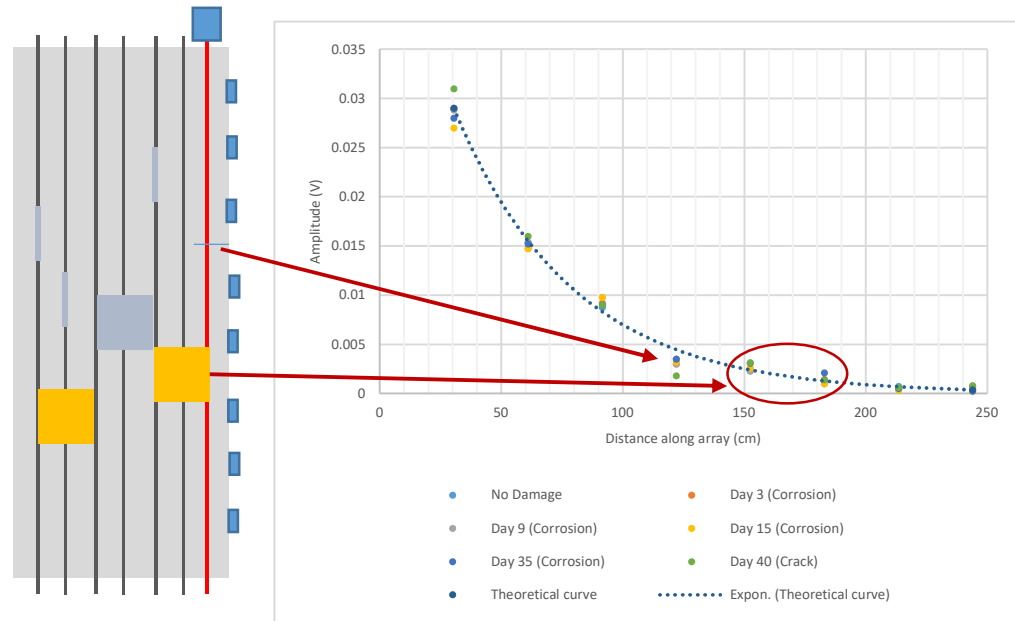
**Figure 15.** Amplitude versus distance plot for Specimen Set 2 using 2 inch transducers as sensors (array of eight sensors) when the transmitter is placed on the far-right rebar.

Sample results of the array using the 2 inch transducer are shown in Figure 15 for the case when the right-most rebar is used as a wave guide. This experiment was intended to investigate the ability of the method to identify a crack in the concrete simultaneous with corrosion progression. The impact of the embedded crack is attributed to the amplitudes detected by the sensor located roughly at 122 cm (48 in), which are consistently lower than the theoretical values. The detection of the corrosion region (which is expected to change over time) is more difficult. A slight increase in amplitudes was detected by the sensors located roughly at 152 cm (60 in) and 183 cm (72 in). This uncertainty is attributed to (i) the energy already having attenuated significantly by this point and the amplitudes already being very small, and (ii) the positioning of the sensors possibly not being optimal when the leakage angles are considered.

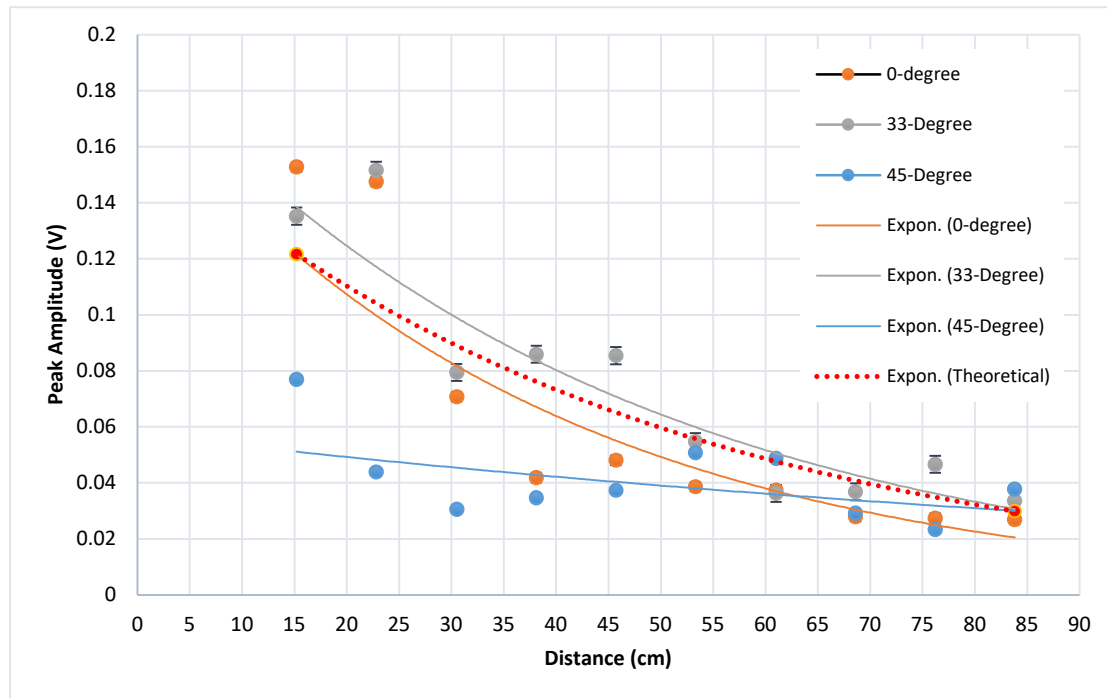
**Figure 16.** Comparison of the peak amplitudes and attenuation curves for the 0, 33, and 45 degree specimens.

As expected, maximum energy transfer was achieved with the 0 degree specimen with a peak amplitude around 0.15 V. The 33 degree specimen provided comparable peak amplitudes (around 0.14 V) but greater scatter due to the fact that additional modes of ultrasonic waves were excited that led to additional reflections of the leaked waves from the boundaries of the wave guide. In the case of the 45 degree specimen, much less energy was transmitted longitudinally, resulting in much lower amplitudes detected from the concrete surface along the array. Given the significant loss of energy in this setup along with highly scattered data, this angle of attachment (45 degrees) was concluded to be infeasible for field applications. A 33 degree angle or lower appears to be optimal—a compromise between feasible attachment on a horizontal rebar and maintaining most of the energy longitudinally in the wave guide. However, further work will take place in future phases of this project to investigate other angles between 0 and 33 degrees.

One of the purposes of these specimens was to investigate the amount of energy transfer with different bar end angles, to identify a feasible angle to attach a sensor to a rebar from the top with an angled seat, yet still achieve the guided wave phenomenon to a reasonable degree. For this purpose, the ends of the rebar were cut at 0, 33, and 45 degrees to simulate angled transmitter-to-rebar attachment scenarios. Figure 16 shows a combined plot obtained for these specimens with both data points and their exponential trendlines, as well as a theoretical curve. The theoretical curve was obtained using Equations (1)–(3). An upper boundary of attenuation coefficient was utilized in this case, based on previous work done by Garcia, 2016 [6], where it was found that the dimensions of the specimen tested are an important factor. In fact, the smaller the dimensions of the specimen, the more likely it is for the reflection within the concrete to be detected by the sensors. This, in turn, results in higher amplitude readings at the starting end of the guided wave and, thus, a higher attenuation coefficient. Instead of a variable coefficient, considering the smaller size of these specimens, a high attenuation coefficient is used in Figure 16. In addition, the larger variation of readings when the transmitter and the receiver are closer is also attributed to reflections. The generated ultrasonic waves would include both shear and longitudinal wave components. While the initial reading points can receive leaked energy and reflections from both wave forms, as the energy attenuates, later measurement locations along the array are more likely to receive only the leakage from longitudinal waves.

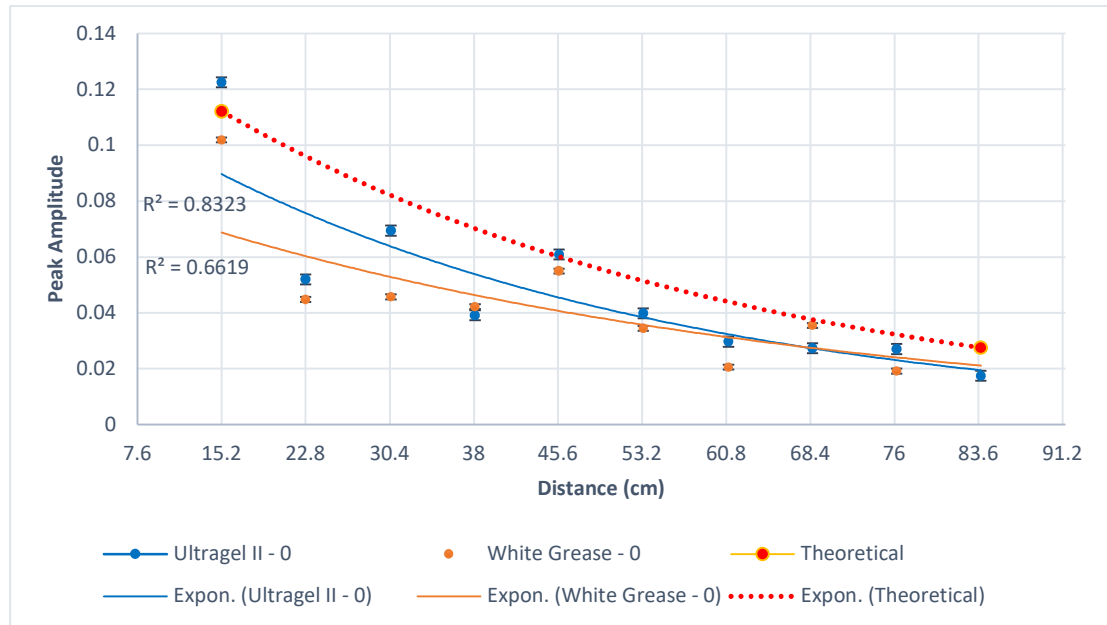
It can be seen in Figure 17 that not only are the peak amplitudes for coupling with Ultrigel II slightly higher than those with WLG, but the exponential curve is also closer to the theoretical curve. Further, the R-squared value for an exponential trendline is higher for Ultrigel II. Another advantage of Ultrigel II is that it can be easily wiped off the surface compared to White Lithium Grease. On the other hand, each data point in Figure 17 represents 20 trials, and it should be noted that the standard deviation for each test location was slightly higher with Ultrigel II (0.0018 versus 0.0008 for WLG); this is likely because it is less sticky than WLG and creates more room for user errors when measurements are repeated. Therefore, care should be taken to ensure consistent measurements with Ultrigel II. In conclusion, the difference is not very significant, and either couplant can be used in this method; however, Ultrigel II appears to be slightly more efficient.

**Figure 17.** Plot obtained from the 0 degree specimen for comparison between Ultragel II and White Lithium Grease.

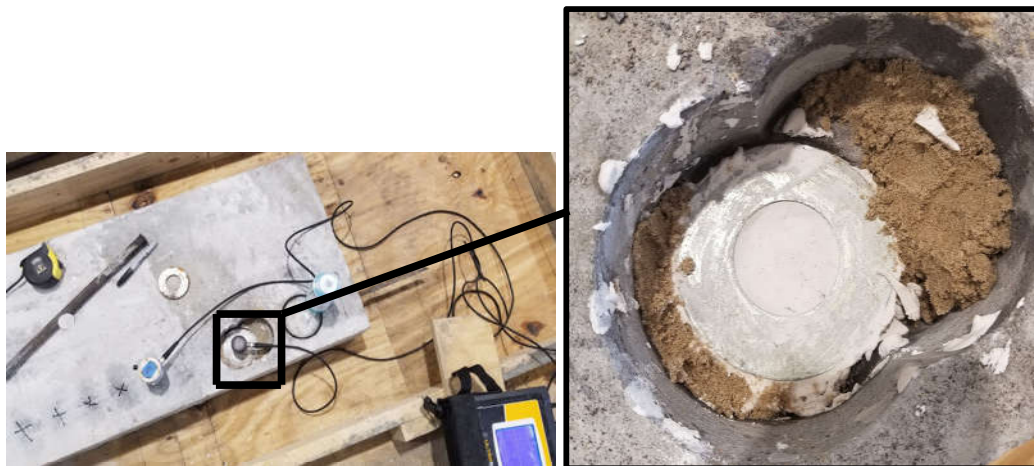
The 45 degree test specimen was cored to the rebar level using a hitch mounted core drill; then, the top surface of the rebar was ground flat and a seat was created using the Hydrocal gypsum paste to replicate the gypsum seat attachment that would be made in the field (Figure 18). The ultrasonic pulses were transmitted from this point and monitored using receivers at five equally spaced spots on the top surface of the specimen along the rebar.

**Figure 18.** Hydrocal gypsum cement placed on top of the rebar to improve the coupling condition.

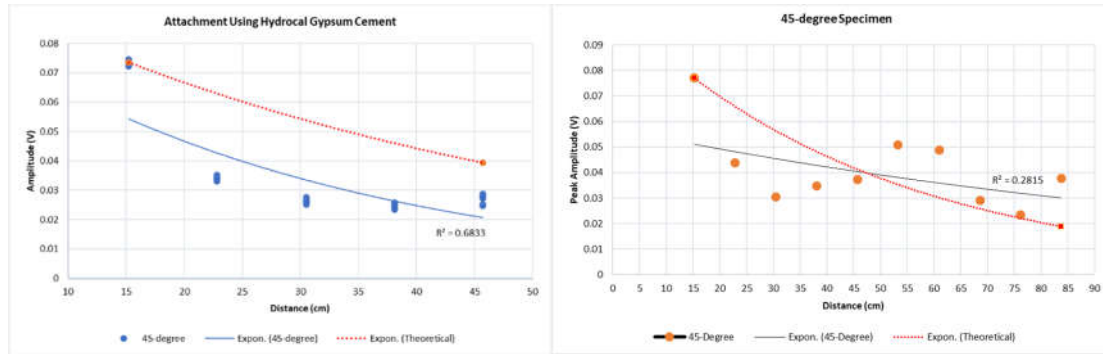
The results for this experiment are shown in Figure 19 in comparison to the original data from the 45 degree specimen. As can be seen, coupling perpendicular to the bar with gypsum (Figure 19, left) actually works better than the end of rebar with a 45 degree angle, given the better fit with an exponential curve and the theoretical curve, as well as similar peak amplitudes to those observed when sending the energy from the end of the wave guide (Figure 19, right). This is attributed to two factors: (1) it is difficult to be consistent when a larger-diameter transmitter is placed on the inclined,

**Figure 19.** Left: Measurements from the cored 45 degree specimen with transmitter attached perpendicularly to the bar with Hydrocal gypsum (as shown in Figure 18). Right: Measurements from the 45 degree specimen with transmitter coupled with WLG at a 45 degree angle to the longitudinal axis of the rebar from the end.

Based on these two stages of testing (rebar only and within concrete), the use of a Hydrocal quick-setting gypsum cement seat with an angle lower than 45 degrees is recommended for field applications.

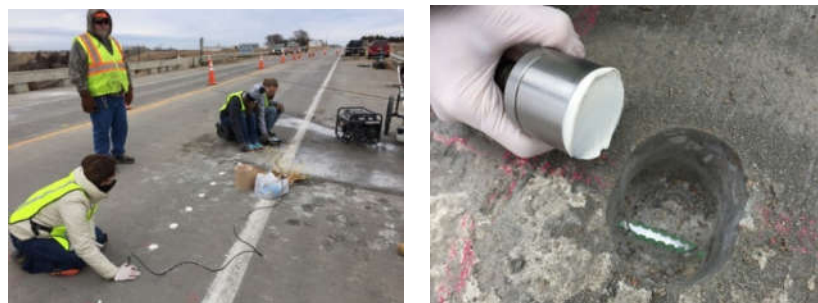
The first bridge deck trial took place in the earlier stages of the project to understand the challenges that must be researched further to implement the proposed method in the field. This pilot test was conducted on bridge S006 30574 of the Nebraska Highway System, located near the town of Emerald (henceforth referred to as the “Emerald Bridge”). There were two testing locations: one in the north lane and one in the south lane. At each location, the concrete was cored to the level of the top rebar, and the surface of the rebar was ground to create a smooth and flat surface for better coupling (Figure 20). Two types of sensors, one of 2.5 cm (1 in.) and one of 5 cm (2 in.) diameter, and WLG as couplant were used. Figure 21 shows the average results (for five readings at each point) for the 5 cm diameter sensor on the north lane. The amplitudes from the smaller sensor were too low to be useful, and it is not recommended for field use without an amplifier. The results from the south lane are very similar; thus, for brevity, they are not represented here.

**Figure 20.** Images from pilot field work.

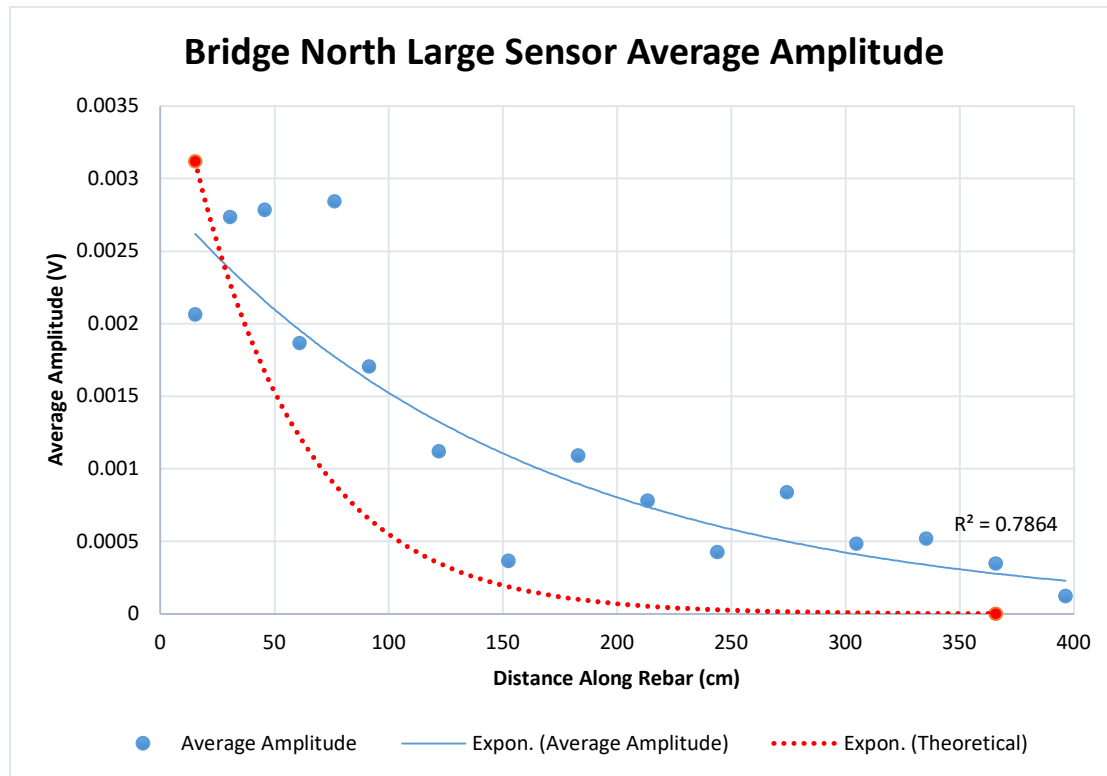
**Figure 21.** Sample results from Emerald Bridge pilot field testing.

- Finally, without baseline data, these instantaneous measurements cannot conclusively reveal any flaws in the bridge deck. If the same rebar/locations on the bridge deck were to be tested regularly after this first data set, significant deviations could point out deterioration progression. Hence, the strength of the method is as a continuous monitoring tool, or SHM technique, where small changes due to new or progressing flaws can be detected as the bridge deck ages, but not as an instantaneous inspection method (such as ground penetrating radar, etc.). However, if a significant data pool can be established from various bridge decks with different conditions and over long periods, a quantitative correlation of amplitudes to verified anomalies can be made and the method can also be used for instantaneous inspections of reinforced concrete bridge decks in the future.

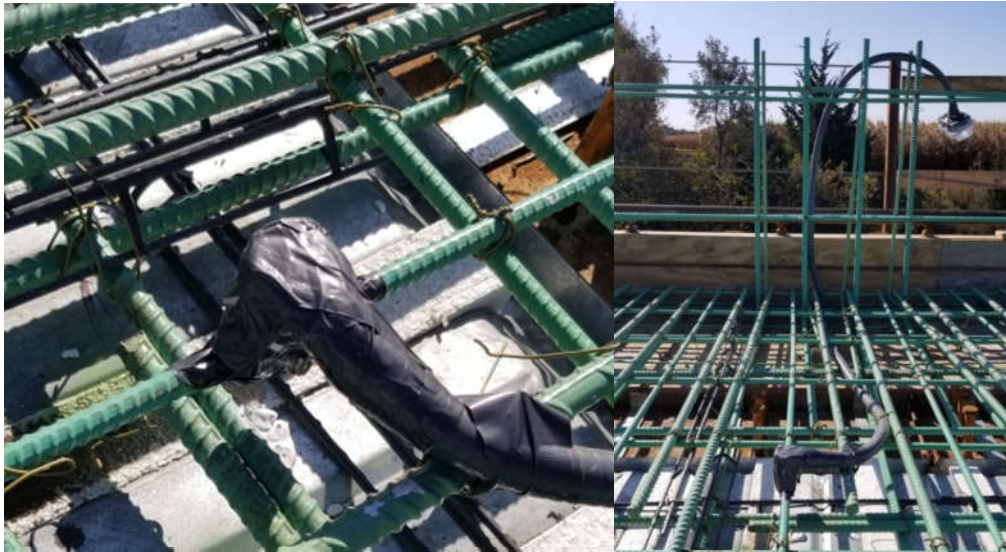
Another field study was performed on the Dwight East Bridge near Valparaiso, Nebraska (henceforth referred to as the “Valparaiso Bridge”). In this study, a sensor was attached to a Number 4 transverse, epoxy-coated rebar on the west side of the bridge deck as shown in Figure 22. Hydrocal gypsum cement was applied onto the rebar to facilitate permanent attachment of the transmitter to the rebar at that location, and the attachment was wrapped in water-proof duct tape. A BNC RG58 coaxial cable was connected to the sensor at one end, and the other end of the cable was enclosed inside a water-proof box to stay outside on the side of the bridge as shown in Figure 22. After the arrangement was made, the concrete was poured.

**Figure 22.** Valparaiso Bridge instrumentation. Left: gypsum seat attachment of the ultrasonic transmitter wrapped in duct tape. Right: the sensor cable was protected in protective plastic pipe and ran to the shoulder of the bridge.

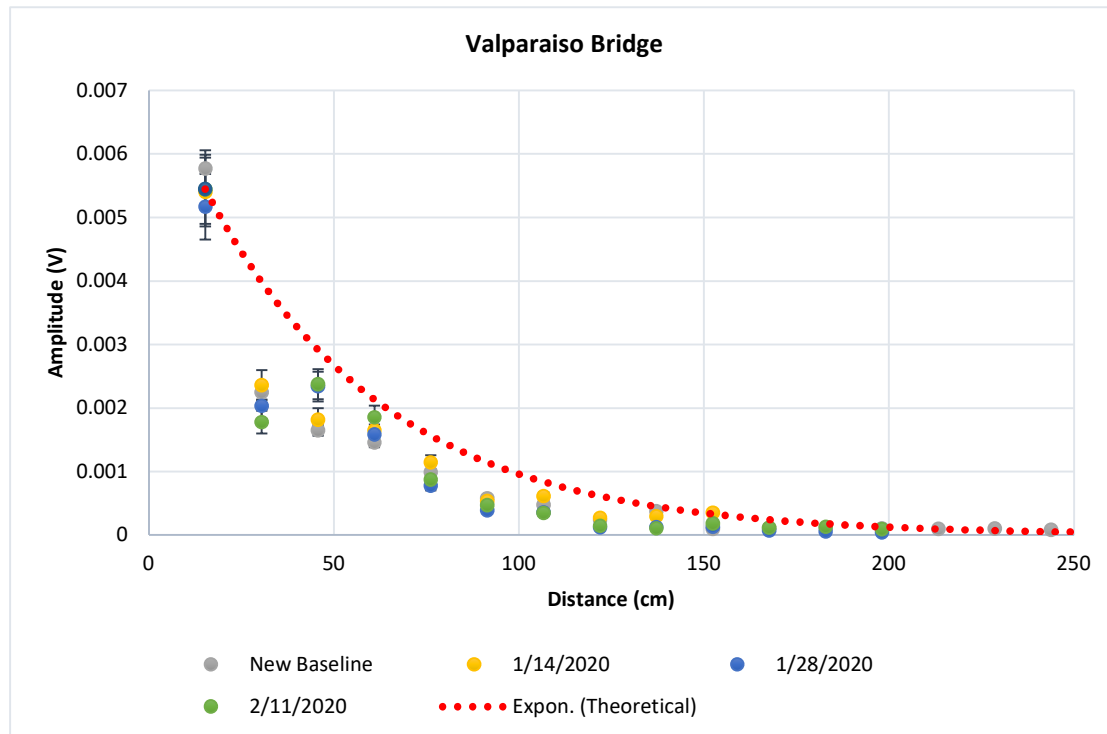
After the curing was complete and the bridge was ready for monitoring, the first set of data (baseline) was collected. The transmitter is located approximately 196 cm (77 in.) from the edge of the bridge, which is the first point for which the measurements are taken. The testing was done along the rebar on the bridge in the transverse direction, covering a full lane and part of the other lane, making a coverage length of 427 cm (14 ft.). Ten data points were collected for each test location for the first few points, where the distance between the transmitter and the receiver is less. This is because the ultrasonic measurements are more sensitive for a shorter distance of travel. For other test locations, as the distance between the transmitter and the receivers increased, five sets of readings were collected for each test location. Figure 23 shows a combined plot of the data that were collected on different dates along with the baseline data. As expected, in each set, the wave energy attenuates exponentially as the distance between the transmitter and receiver increases. The amplitudes decrease substantially after 91 cm (36 in.), rendering the remaining readings too small for monitoring for small changes. A signal amplifier, if one that matches the appropriate frequency range can be located, may help in the future to increase the gains. In addition, as can be seen in Figure 22, the transmitter is located close to the intersection of longitudinal and transverse bars, potentially attenuating some energy in both directions and causing the reduced measurement distance in comparison to the Emerald Bridge. Future studies will try to identify locations that are farther from rebar intersections, if possible.

**Figure 23.** Baseline data versus other days for Valparaíso Bridge.

This bridge will continue to be monitored as a long-term SHM study, ideally over a few years, as near-term deterioration is not expected in this brand-new bridge with epoxy-coated bars. In the future, an additional site will also be instrumented—this time ideally a patching project on an older bridge, where some deterioration may occur sooner, and the method can inform the deterioration progression and durability of such repair projects.
